PEREGRINE: MISSION 1

Post-Mission Report

AUGUST 2024

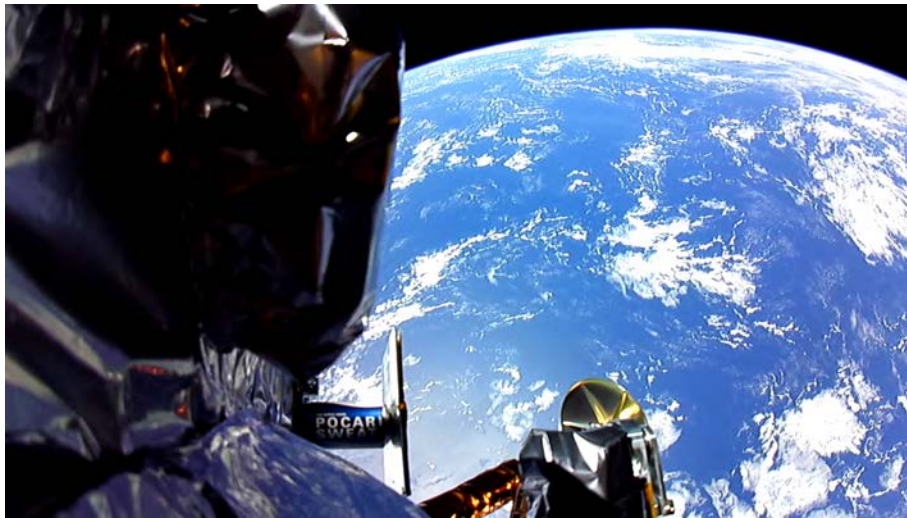
FIGURE 3: This image was taken by camera 1 moments after successful separation from United Launch Alliance's Vulcan rocket. Counterclockwise from top left center is the DHL MoonBox, Astroscale's Pocarí Sweat Lunar Dream Time Capsule, and a Peregrine landing leg. In the background is our big blue marble, our home planet, Earth.

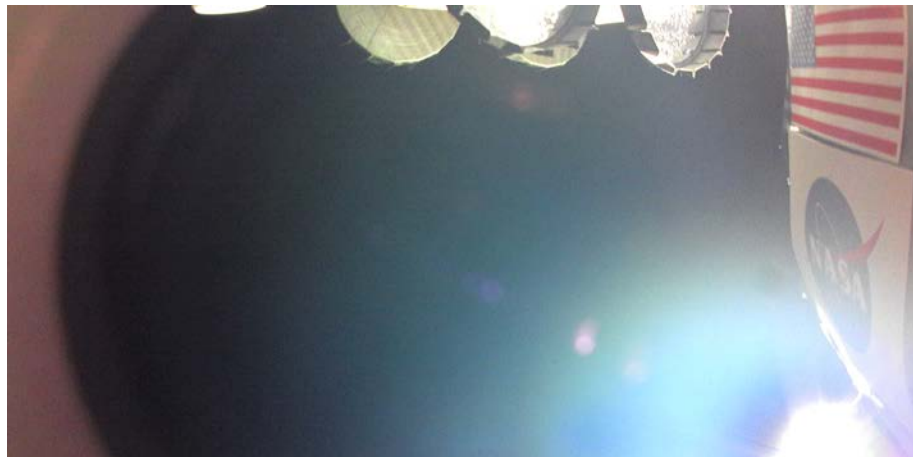
FIGURE 7: This image was taken by camera 4. Top center: Carnegie Mellon University's IRIS rover wheels. Right: United States of America flag and NASA logo affixed to Peregrine's tank D.
